## Subject: New Additions to Mid-size Historic Buildings

October 2001, ITS Number 18

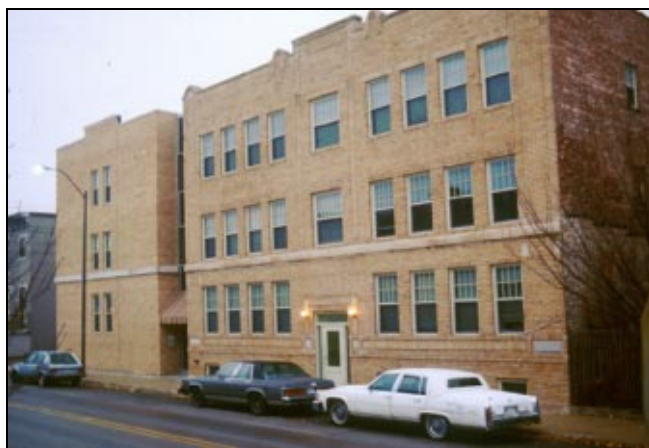
**Application 1** (*Compatible treatment, Appropriate addition*): Constructed in 1914, this three-story apartment building was built to the front property line of its site. Architectural detailing in face brick and stone distinguish the facade from the plain side walls of common brick. The addition which is roughly half the size of the original building attaches along the full length of one of the plain, side elevations. The street elevation of the addition is in the same plane as the original facade, consistent with other buildings in the historic streetscape. Although similar in form and materials, the composition and details of the new facade are more simplified. The distinction between the old and the new is reinforced by a narrow recessed connector faced with a glass curtain wall. The size and placement of the connector prevent the glass and metal from becoming too sharp a contrast that would make the connector itself an incompatible feature.

*The slight recess at the intersection of the addition (left) and the historic facade (right) allows the visual mass of the original building to remain unchanged.*

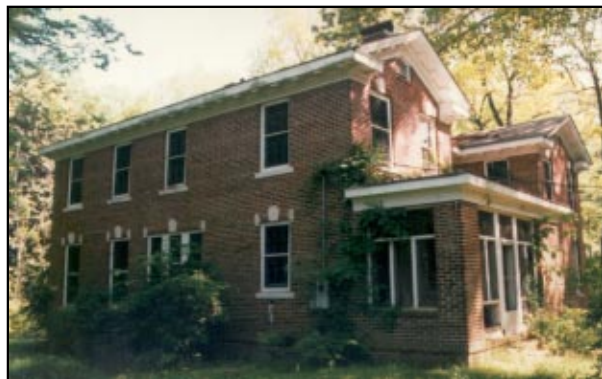
This freestanding Colonial Revival style house was built in 1928 on a large site that remains somewhat wooded. The proposed addition has a footprint nearly twice the size of the original building, which is far too large to be offset even by its location at the rear of the house. There is little in terms of design or proposed materials to distinguish the new construction from the original house. In addition the architectural elaboration of the two new side entrances makes them strong elements that diminish the importance of existing character-defining features. The historic setting is also altered by so large an addition as well as the extensive paving for drives and parking lots.

*Shown is the side of the historic house illustrated in the elevation (below, left).*

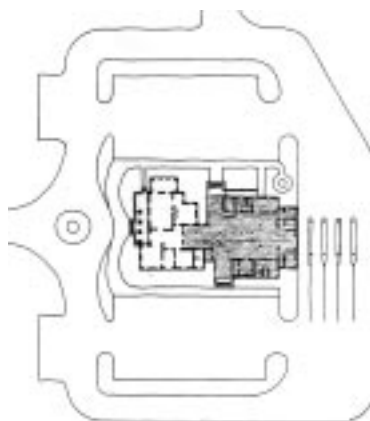
*Shown as shaded in the drawings, the relatively large size of the proposed addition is apparent. The plan view shows the vast expanse of paving.*

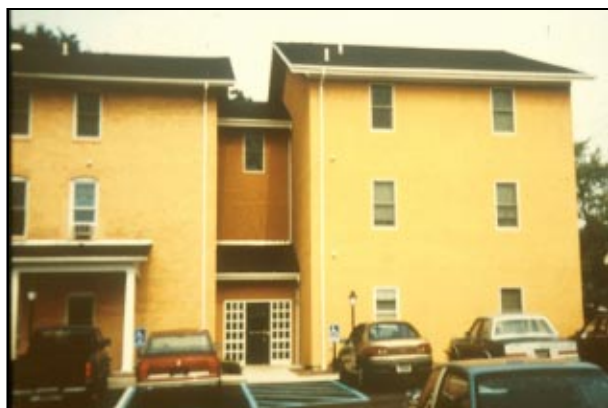
**Application 3** (*Compatible addition*): This small roadside hotel has been modified and expanded many times since its construction in 1853. The recent rehabilitation included another addition at the end of the rear wing. It is similar to the existing rear wing yet differentiated. Though the color is the same, the addition is stucco rather than brick. Windows are the same type and proportion, but the new ones have a simple lintel rather than a brick arch. The width of the addition and the slope of its roof match the rear wing but a small recessed connector separates the new from the old. The simplicity of the design and the location at the rear minimize the impact of this compatible addition.

*Rear of hotel showing original building (left), new addition and recessed connector.*

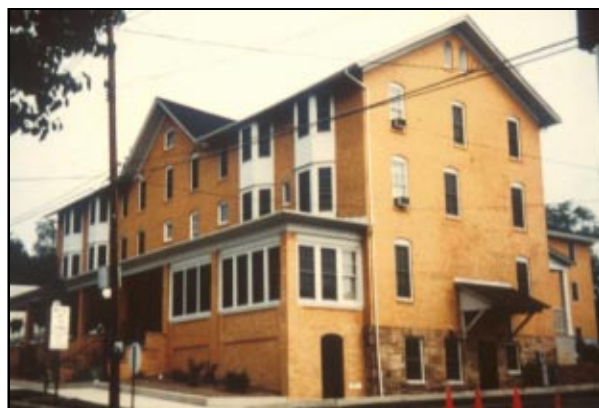
*The new addition is not visible from the front of the building.*
